## INSPECTION DEPARTMENT

Factory Mutual  
Fire Insurance Companies.

Boston, Mass. May 5th. 1898.

ROOF OF  
Mass. Institute of Technology  
Buildings  
Damaged by Fire April 27, 1898.

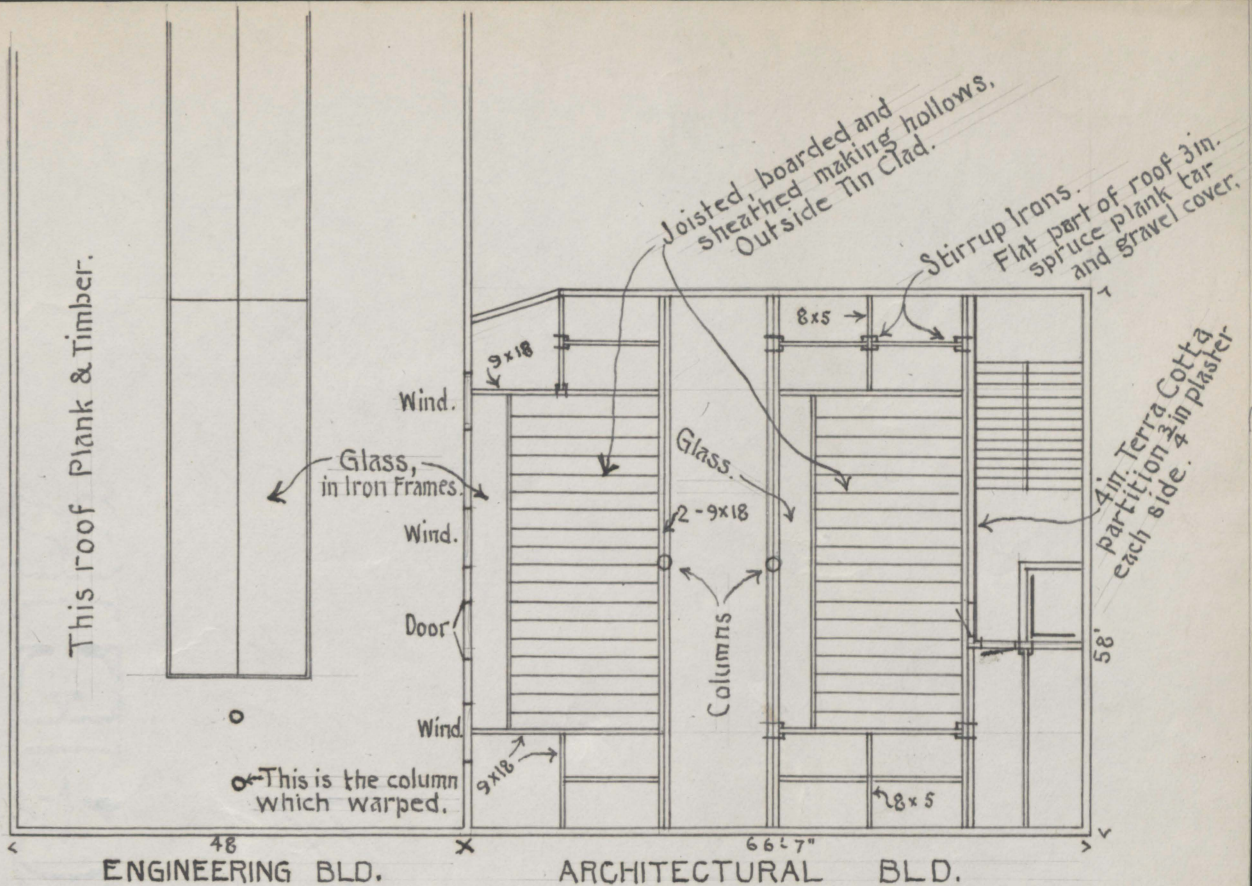
ROOF PLAN.

The roof of the Architectural Building is shown by the sketch inclosed. The skylights were entirely destroyed, hardly a vestige remaining. The hard pine timbers in both buildings were burned in fully 1" and the fire extended back into the Engineering Building for about 60 Ft. and entirely destroyed half of the skylight in the Engineering Building. Back of this point the fire scorched things as far as the partition to the stair tower. The lath and plastering <sup>partitions</sup> in the Engineering Building was honeycombed. The roof plank in both buildings was burned in fully 1". In the Architectural Building beside this burning, the half-inch sheathing on the ceiling was entirely consumed so that the only evidence of it having existed was a few finishing nails which remained in the plank. In a number of places the plank was burned in so that the

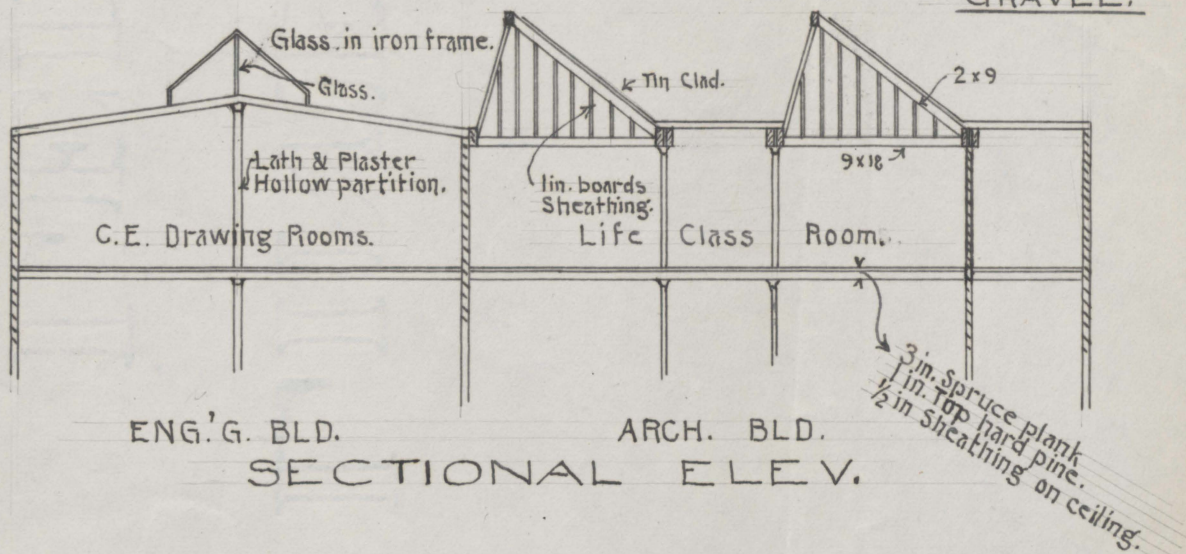
SECTIONAL ELEV.

The hollow joisted construction of the large sky-lights in the ~~roof~~ Life Class Room undoubtedly added more fuel to the fire and it appears very possible that if these skylights had been of mill construction and wire-glass had been used, the fire would have been materially retarded, for the hot gases would have accumulated near the roof and as the top of the windows were on one side 2 Ft. and on the other 4 Ft. below the ceiling the chance for the wind to work would have been lessened.
