NAVY DEPARTMENT
DAVID TAYLOR MODEL BASIN
WASHINGTON, D.C.

ADDITIONAL NOTES ON THE CONDITIONS OF FRACTURE
OF MEDIUM STEEL SHIP PLATES

D.F. Windenburg, Ph.D.,
and
Captain W.P. Roop, USN

Report R-271

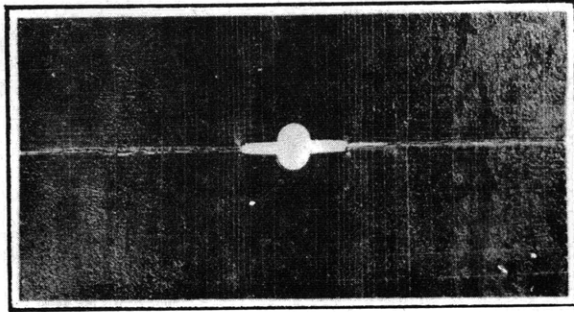
Figure 3b - The Separated Parts Rejoined after Fracture

It is to be noted that the form of the grid lines after rupture, as shown in Figure 3b, indicates little evidence of permanent deformation except in the immediate vicinity of the ends of the slot. The sawcut has increased to several times its initial width and the grid lines at the ends of the cut show considerable local deformation. At the left end of the notch there is a distinct dimple which indicates localized decrease in thickness. It is clear that before the cleavage fracture started high values of plastic strain existed at this point; their effect on elongation is small, however, because the area of high strain is extremely localized.

At the right end of the slot, Figure 3b, a rather curious feature appears. It will be observed that whereas the left end of the slot opened because of plastic flow at its end, the right end opened by parting of the plating. The nature of this fracture is shown in Figure 3c. It has the appearance of a thumb print in the metal itself on both halves of the ruptured specimen. The region inside the print probably broke first with a cleavage fracture, with the point of initial fracture at mid-thickness about $1/8$ inch from the end of the sawcut. The cleavage fracture next spread over the entire area inside the print but the small area at the edge of the print remained ductile and elongated appreciably before final fracture of the remaining section. In fact, it was possible to insert a thin knife blade into the print from the end of the slot for a considerable distance before there was any visible opening in the side of the plate.

The feature just described has been observed frequently in other tests. The parting apparently starts inside the plate and extends over an appreciable area before it can be seen from the surface. However, the presence of the internal crack is disclosed by local plastic flow in the surface.

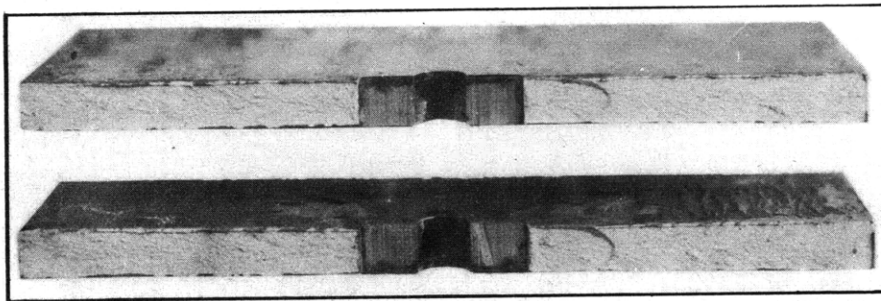
Figure 3c - The Two Faces of the Fracture Surface

As previously mentioned, the fracture of Specimen 110 was apparently initiated at mid-thickness about $1/8$ inch from the end of the slot. A close study of Figure 3c reveals a small area at each end of the slot, resembling the half-moon of a fingernail. It is towards this area that the chevrons converge. Consequently, the rim of this area is considered to be the origin of the fracture.

Illumination is from above on the right; the oval areas are both recessed.

The fracture occurred in two abrupt stages. At an average stress on the net area of 42 kipsi* there was a sudden fracture which extended through most of the thumb print, accompanied by considerable noise. This fracture caused the load to fall off about 3 per cent. When the load was reapplied the average stress on the remaining net section had to be increased to 47 kipsi before complete rupture occurred. Had the testing machine contained a greater amount of stored-up energy, it is probable that parting would have been complete at the first rupture. A characteristic of most testing machines is that a sudden increase in elongation of the specimen reduces the applied load; in a ship structure the load is rarely decreased by a partial fracture and thus the stress on the unfractured section, instead of falling off, is actually increased in proportion as the area is decreased.

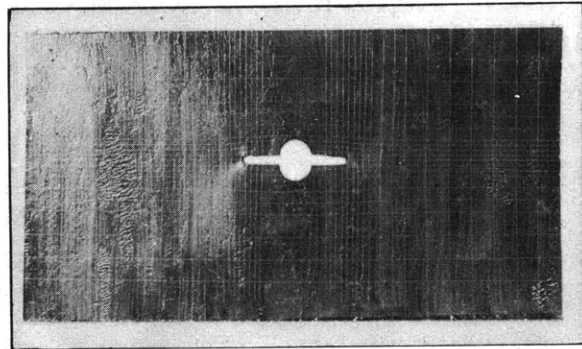
Figure 4b - Intense Local Strain at Ends of Notch

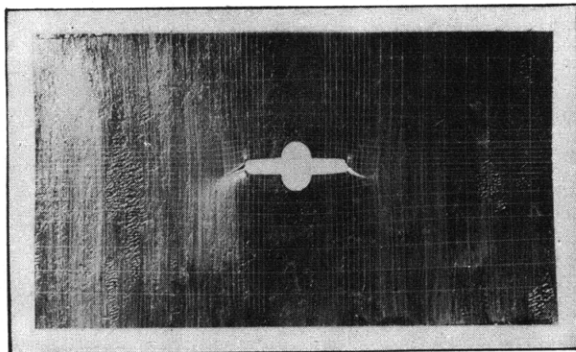
Figure 4c - Shear Rupture Begins
Load Reaches Maximum

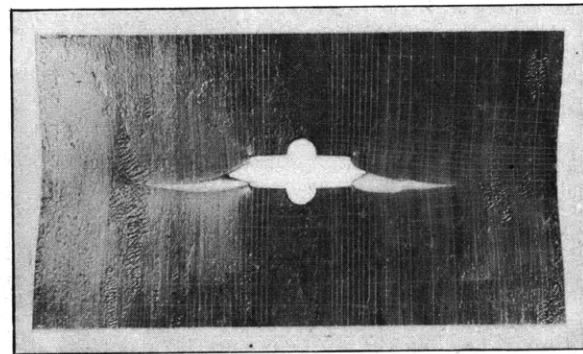
The oblique fracture surface is characteristic of the ductile shear method of rupture. However, it should be pointed out that since the notch is cut square across the plate, the surface of parting first starts in the plane of the notch and then shifts to the oblique configuration. Although it cannot be seen in the photograph, the small area of initial rupture is very similar to the half-moons of Figure 3c.

Figure 4d - Specimen after Rupture
The surface of rupture is on a shear plane about
45 degrees to the direction of loading.

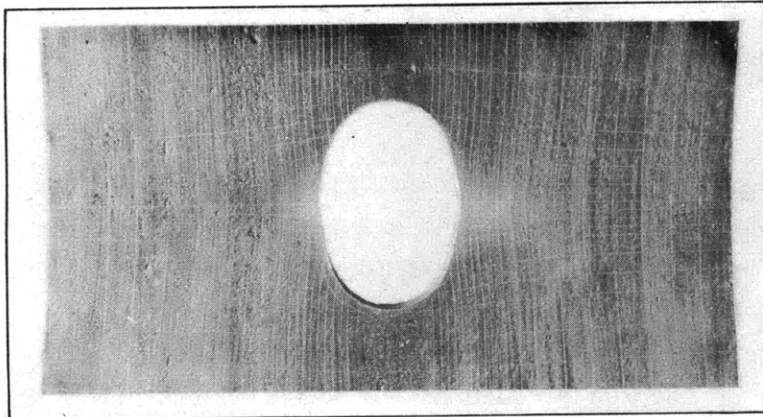
Figure 5b
Rupture at the Sides of
the Hole is Imminent

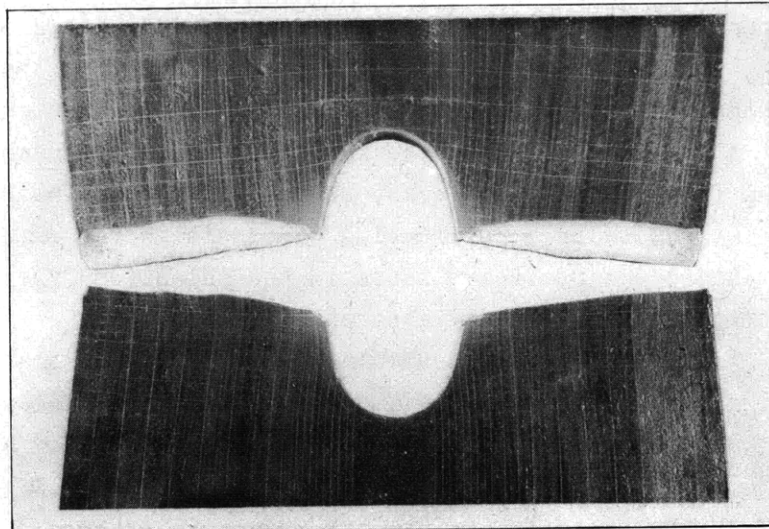
Figure 5c
After Complete Rupture

Specimen 113, tested at a temperature of 85 degrees fahrenheit, was very ductile, failing in a shear rupture. It will be observed from the photograph, Figure 5, that this particular type of notch permits the material to deform in a ductile manner with little restraint. Figure 5b shows considerable necking at the edges of the plate. However, because of the deformation of the hole, the material in way of the hole is not restrained appreciably in the transverse direction and its behavior is similar to that of material in a simple tensile test.

The maximum load reached corresponded to an average nominal stress on the net section of about 60.5 kipsi. This is approximately the same tensile strength as obtained from a standard tensile specimen and indicates that the presence of such a hole in a plate has little effect on the average stress at which rupture occurs.

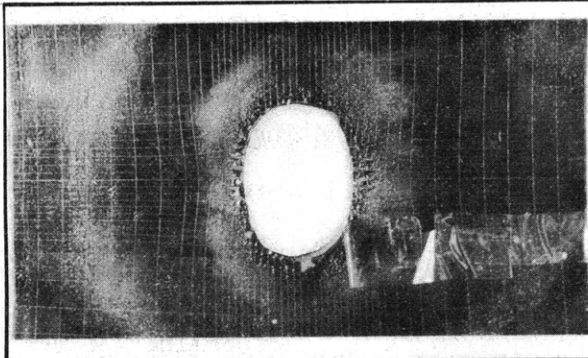
Figure 6b
Intense Local Strain
at Sides of Hole

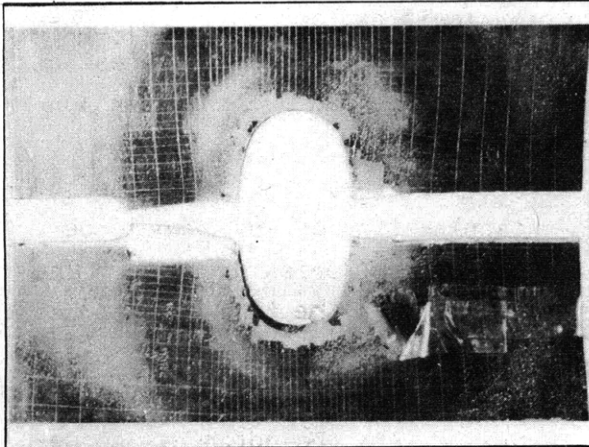
Specimen 114, similar to Specimen 115 except for the heating and quenching just mentioned, was tested at the same temperature as Specimen 115. The deformation of this specimen during test is shown in Figure 6. It will be observed that after a considerable amount of plastic elongation a shear rupture started at each side of the hole. The average stress at maximum load, just prior to the rupture shown in Figure 6c, was 75 kipsi. Although this particular specimen carried the highest load of any of the three specimens with circular holes, the fact is considered not significant. The maximum spread in the values of ultimate strength from the mean value is less than 4 per cent. Such a spread might well occur had the three specimens been tested under identical test conditions. It is believed that the zoned appearance around the hole, Figures 6b, 6c, and 6d, is not of any particular significance, but that it resulted from the angle of lighting and from uneven condensation of moisture on the cooled surface.

Figure 6d
Parting Changed to
Cleavage Mode

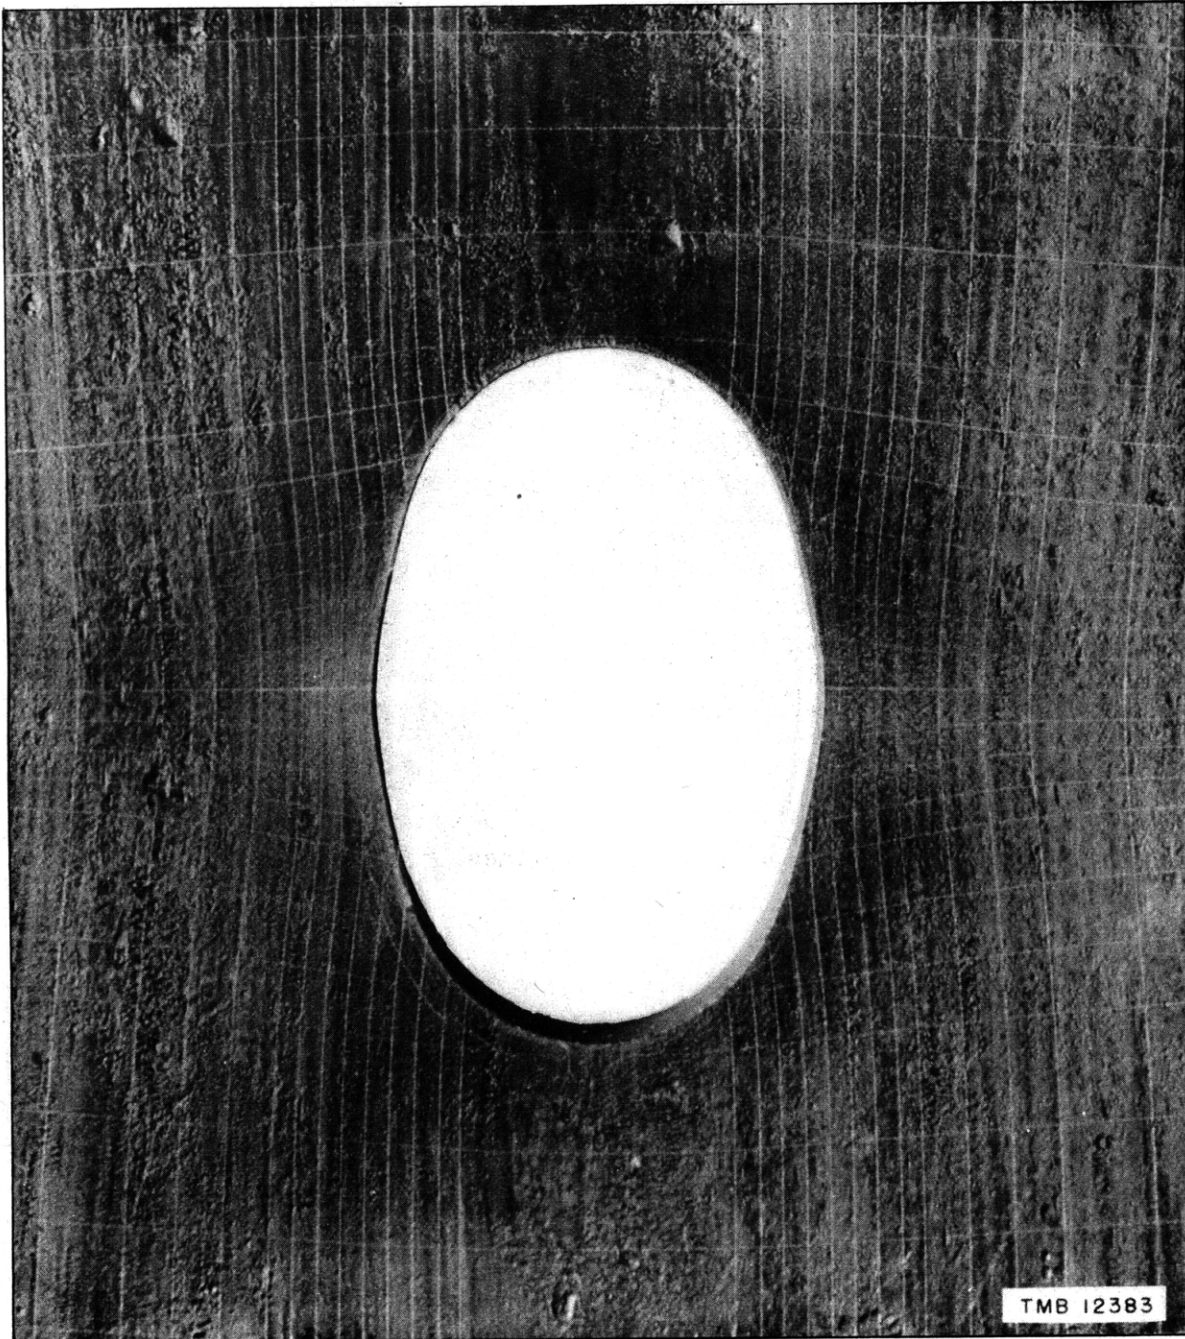
The strain grid for Specimen 113 shown in Figure 5b is reproduced to an enlarged scale in Figure 7. It will be observed that the grid lines, which were originally straight and parallel to either the x- or y-axis, have become distorted. If the separation of the various lines is measured and compared with the original spacing of the lines, the distribution of the principal strains in the vicinity of the hole can be estimated. From these data and the stress-strain curve of Figure 2, the distribution of the octahedral shearing stress and the energy absorbed per unit volume in any given region can be obtained (7). It is also sometimes possible to obtain these same values by determinations of the change of thickness in any given region (8).

Figure 7 - Pattern of Strain Distribution, Specimen 113

The maximum strain approaches the limit which will be accepted by the material before rupture.
The rectangular grid prior to strain is shown in Figure 5a.
