## AN ANALYSIS OF A FAILURE OF KEEL BLOCKS IN A DRY DOCK

BY LIEUT. COMMANDER E. L. GAYHART, (CG), U. S. N.

MAY 1925

REPORT NO. 114

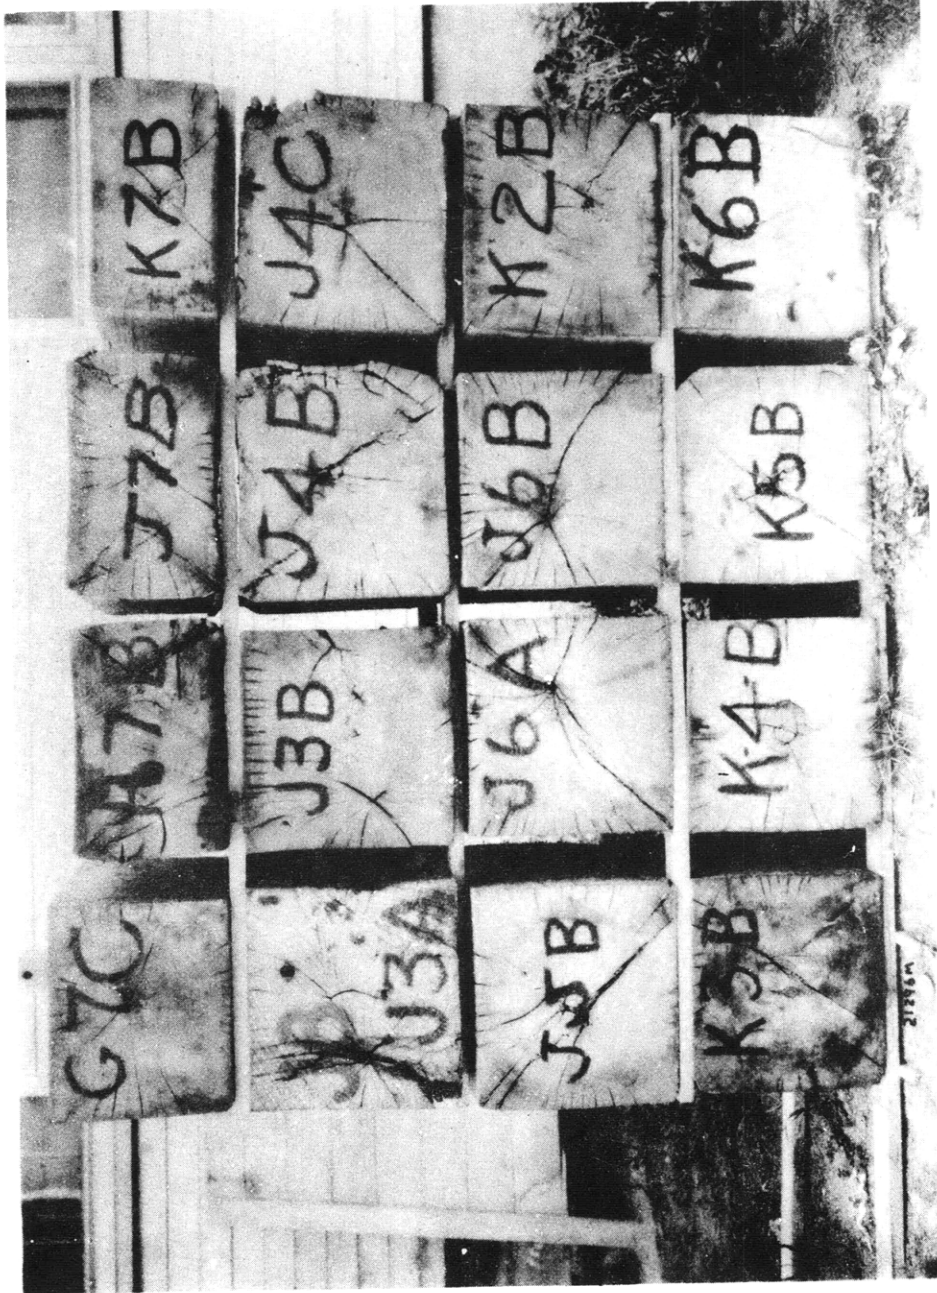
PLATE IV

- IV Forest Products Laboratory - End view of blocks after failure by direct compression.
- V Plot summarizing results of tests at the Forest Products Laboratory.

The type of failure in the 19 inch pieces is shown in Plate IV. It should be noted that such failures were not produced when the sets were tested as a whole but produced when the individual short sections were tested singly. This point must be borne in mind when considering the results of tests to be described later.

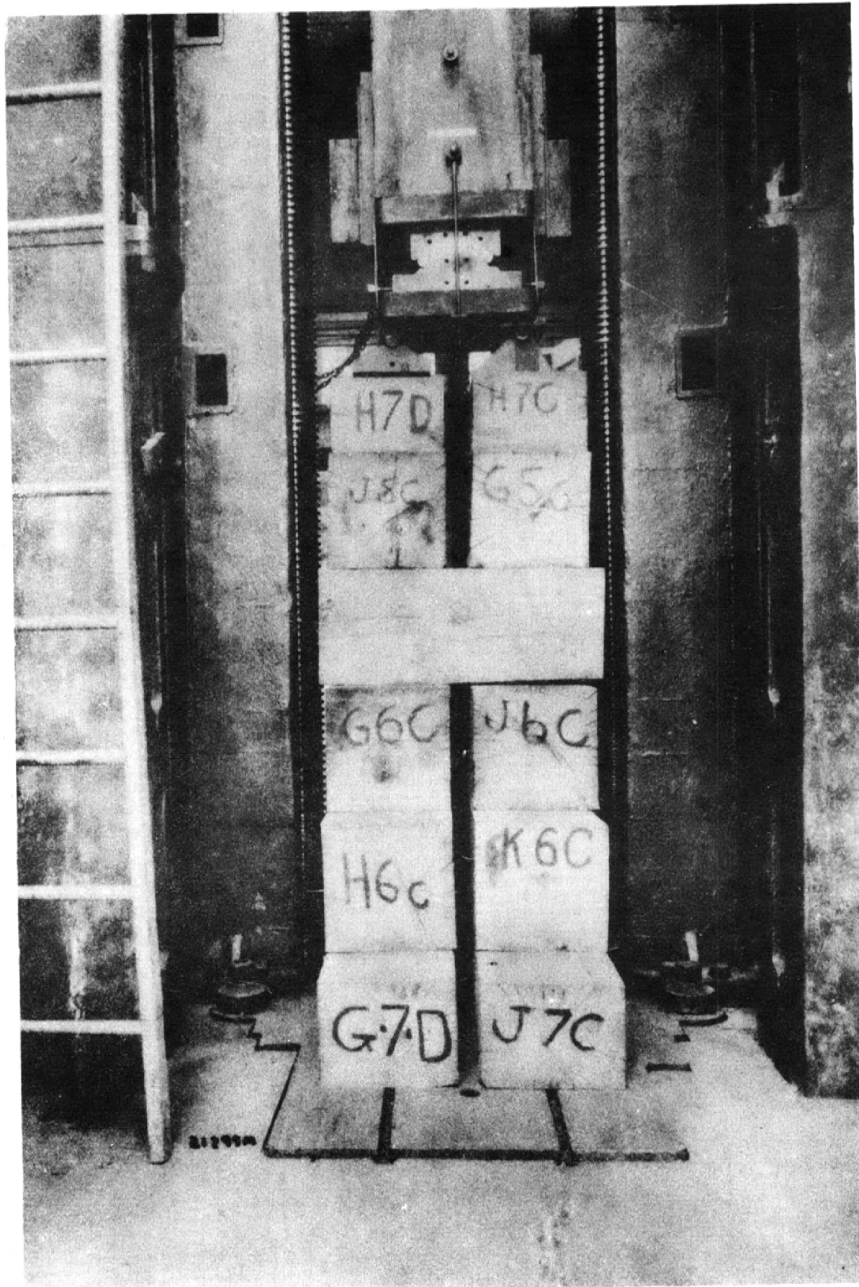
PLATE VI

- VI Forest Products Laboratory - Set up for test of cribbed blocks.
- VII Bureau of Standards - Views of blocks and method of test.
- VIII Bureau of Standards - Stress-strain curves for keel blocks.

The two blocks fourth from the bottom were then swung through a right angle to tie the sets together (see Plate VI) and an additional piece inserted in order to give full bearing for the piece fifth from the bottom. Load was then applied with one of the knife edges purposely placed 1 inch off center. This load was stopped at 250,000 lbs. because of crushing under one bearing (no instability however). The knife edge was then centered and the test load was run up to 434,500 lbs. where it was stopped because crushing and consequent inbedding of the bearing interfered with further use of the machine. There was still no sign of failure by instability.

Attention is invited again to the results obtained from cribbing in the tests at the Forest Products Laboratory. By a simple system of cribbing (Plate VI) the maximum capacity of a pair of 6-high sets was raised from 215,000 lbs. to 434,500 lbs., i.e., more than doubled. and the latter load was limited by the local crushing strength of the wood rather than by instability of the blocks. With blocks 6-high, the practice of cribbing alternate pairs of blocks, or perhaps even one-third of the blocks would probably be found adequate.
