NAVY DEPARTMENT
DAVID TAYLOR MODEL BASIN
WASHINGTON, D.C.

ADDITIONAL NOTES ON THE CONDITIONS OF FRACTURE
OF MEDIUM STEEL SHIP PLATES

D.F. Windenburg, Ph.D.,
and
Captain W.P. Roop, USN

Report R-271

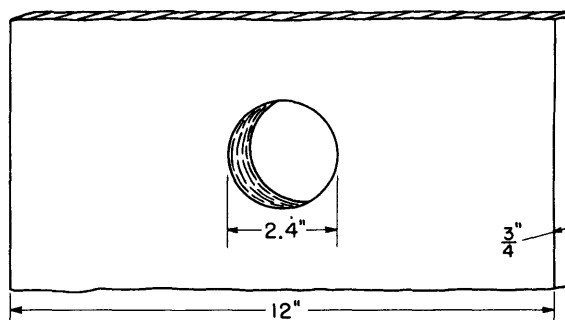
Figure 1b - Sketch of Specimens 113, 114, and 115

All of the specimens were notched at midlength and midwidth. Data on the form of the specimens are given in the sketch, Figure 1. Three of them, Specimens 113, 114, and 115, each had a notch consisting of a simple circular hole 2.4 inches in diameter. The remaining width in way of the notch was thus 9.6 inches; the net area was 7.2 square inches.

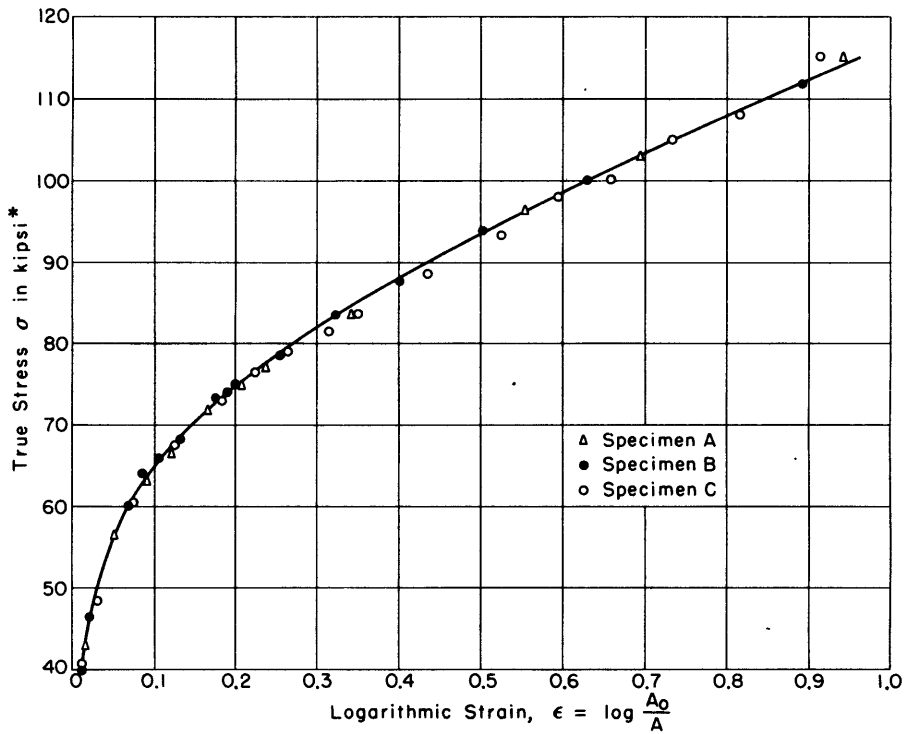
Figure 2a - Data Plotted on Rectangular Coordinates

A representative true-stress-strain curve obtained from the test data on three standard 0.505-inch round tensile test specimens machined from the plate from which the specimens were cut is given in Figure 2.

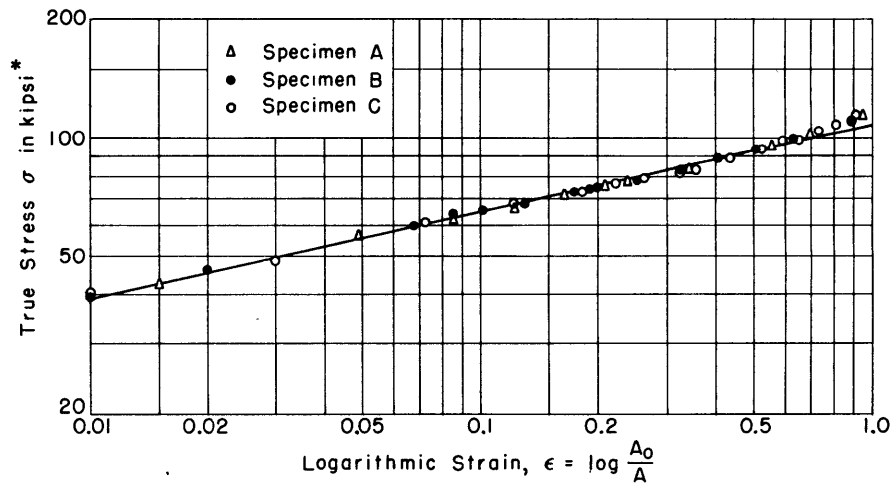
Figure 2b - Data Plotted on Log-Log Coordinates

The experimental points may be represented by the analytical expression $\sigma = 108 \epsilon^{0.224}$ as evidenced by the linearity of the data in Figure 2b. The slope of the line is 0.224 and the intercept at $\epsilon = 1.0$ is 108. In this plot σ is the true stress and $\epsilon = \log \frac{A_0}{A}$ is the natural or logarithmic strain.

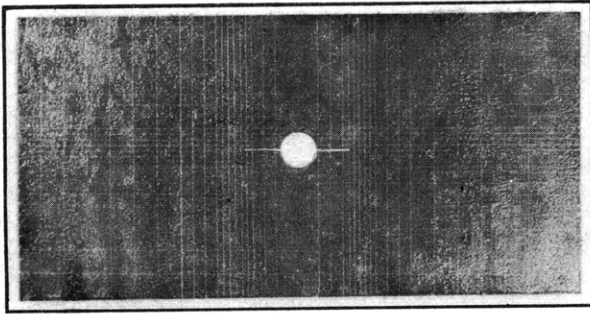
Figure 3a - The Notch and Rectangular Grid before Elongation

Specimen 110 was tested at a temperature of 75 degrees fahrenheit. It broke with a ductile cleavage fracture as can be seen from the photograph, Figure 3 on page 9.

Although observations of the mode of rupture under different test conditions were the main object of these tests, they actually give much more information. Much can be learned from the photographs, Figures 3 to 6. For example, the ductile cleavage fracture of Specimen 110 which was tested at a temperature of 75 degrees fahrenheit is shown in Figure 3. Figure 3c shows the square break, the granular surface, and the herringbone or chevron pattern characteristic of cleavage fractures.

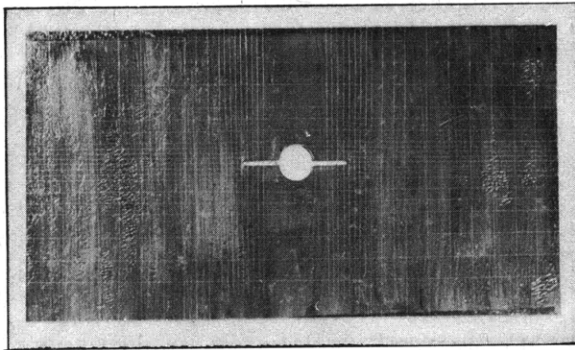
Figure 4a - An Early Stage of Elongation

Specimen 111, which was similar to Specimen 110, was tested at a temperature of 100 degrees fahrenheit. It broke with a ductile shear rupture as shown in Figure 4 on page 11.

Figure 4 - Specimen 111 before and after Ductile Shear Rupture

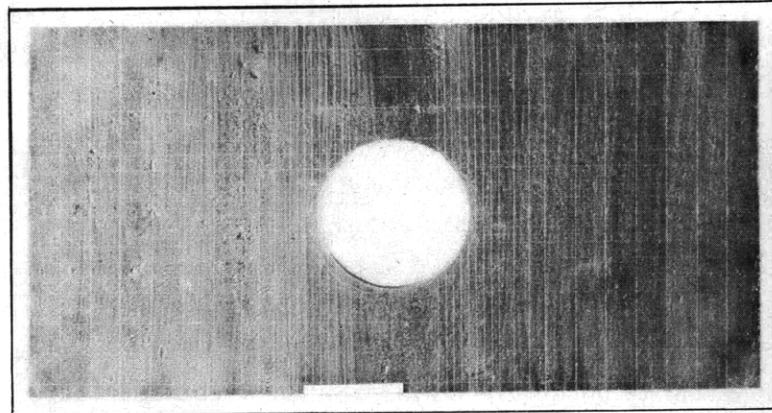
Figure 5a
Before Elongation

Specimen 113, tested at a temperature of 85 degrees fahrenheit, was very ductile, failing in a shear rupture. It will be observed from the photograph, Figure 5, that this particular type of notch permits the material to deform in a ductile manner with little restraint. Figure 5b shows considerable necking at the edges of the plate. However, because of the deformation of the hole, the material in way of the hole is not restrained appreciably in the transverse direction and its behavior is similar to that of material in a simple tensile test.

The maximum strain approaches the limit which will be accepted by the material before rupture.
The rectangular grid prior to strain is shown in Figure 5a.

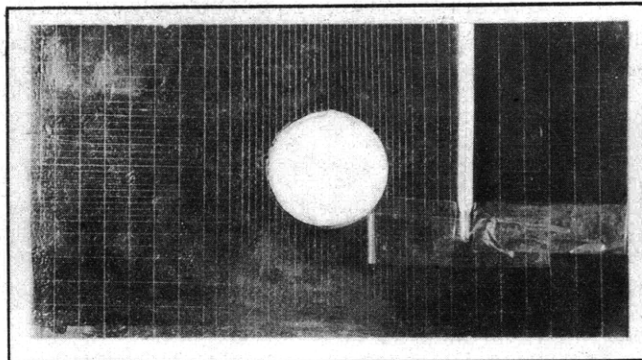
Figure 6a
Before Elongation

Specimen 114, similar to Specimen 115 except for the heating and quenching just mentioned, was tested at the same temperature as Specimen 115. The deformation of this specimen during test is shown in Figure 6. It will be observed that after a considerable amount of plastic elongation a shear rupture started at each side of the hole. The average stress at maximum load, just prior to the rupture shown in Figure 6c, was 75 kipsi. Although this particular specimen carried the highest load of any of the three specimens with circular holes, the fact is considered not significant. The maximum spread in the values of ultimate strength from the mean value is less than 4 per cent. Such a spread might well occur had the three specimens been tested under identical test conditions. It is believed that the zoned appearance around the hole, Figures 6b, 6c, and 6d, is not of any particular significance, but that it resulted from the angle of lighting and from uneven condensation of moisture on the cooled surface.

This specimen was tested at a temperature of 75 degrees fahrenheit. The mottled appearance around the hole is due to drops of water on the plate. The thermometer used to gauge the temperature was attached to the specimen, as shown in Figure 6a, by scotch tape.
